CADIA VALLEY OPERATIONS
Newcrest Mining Limited

Blayney Copper Mine Rehabilitation

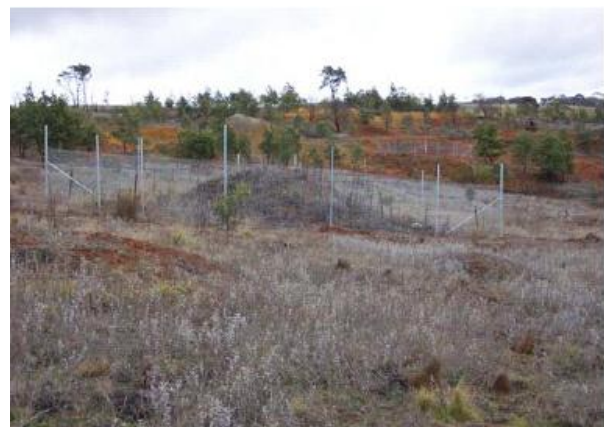
Secured shafts at Blayney Copper Mine
